AIRCRAFT ACCIDENT REPORT

ASSOC/2013/10/03/F

Accident Investigation Bureau

Report on the Accident involving Associated Airlines Limited Embraer 120 ER aircraft with registration 5N-BJY, which occurred at Murtala Muhammed Airport, Lagos on 3rd October, 2013.

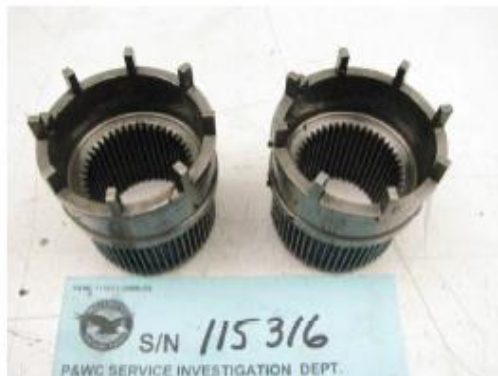
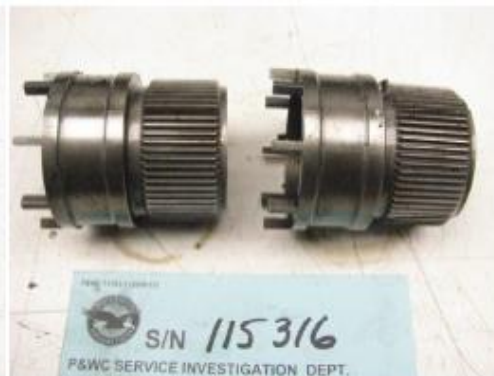
- 6.1 The input-drive housing of the RGB housing set was fractured in large multiple fragments. The oil spray-nozzle transfer tubes of the 1st stage reduction gears and bearings (No. 8 to 12) were fractured. After removal of the housing fragments, the RGB gear-train could be rotated freely. Water, dirt and few brick-red tile fragments were contaminating the oil compartment of the 1st stage reduction gear-train. The lay-shafts and couplings, and the helical gears, input shaft and bearings composing the 1st stage reduction gear-train of the RGB were intact but the gears and bearings were dry and displayed stationary surface corrosion characterised by the rusty-orange and dark oxide discolorations. Refer to photo no's 108 to 124.

Alternate views of the condition of the LH and RH layshaft vernier-couplings.

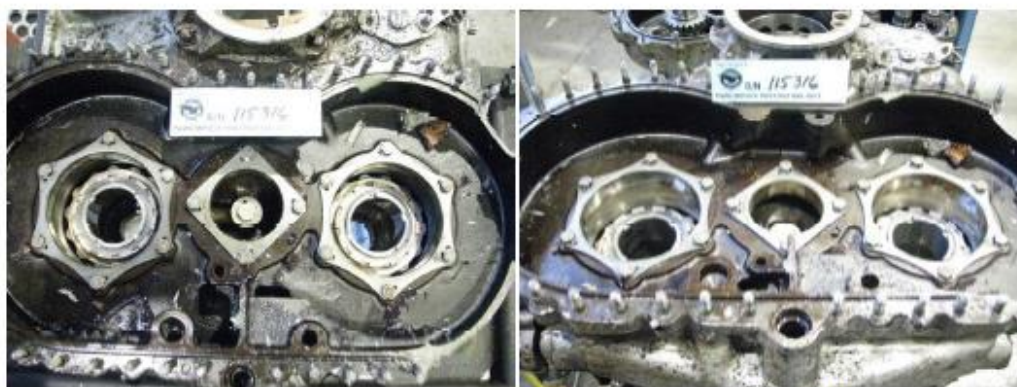
Alternate views of the contaminated RGB rear-housing compartment of the installation of the 1st stage reduction gear-train and bearings.

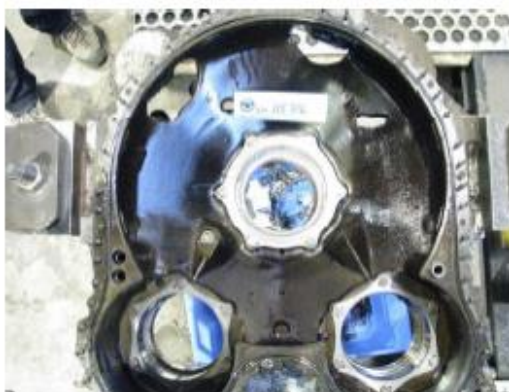
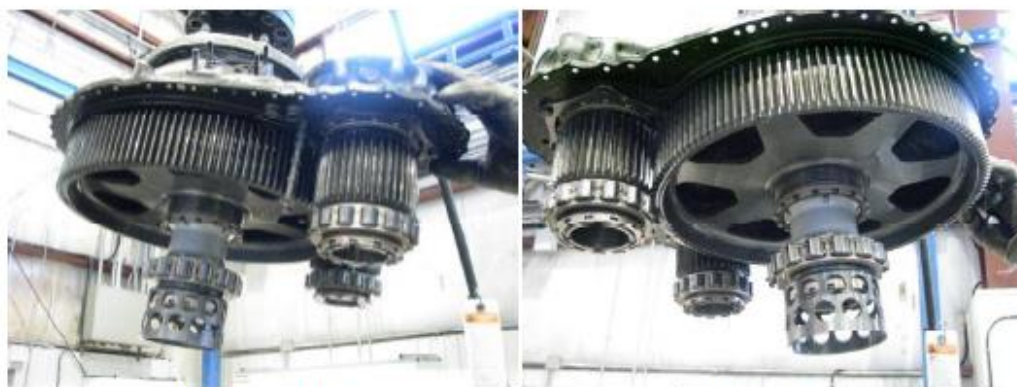
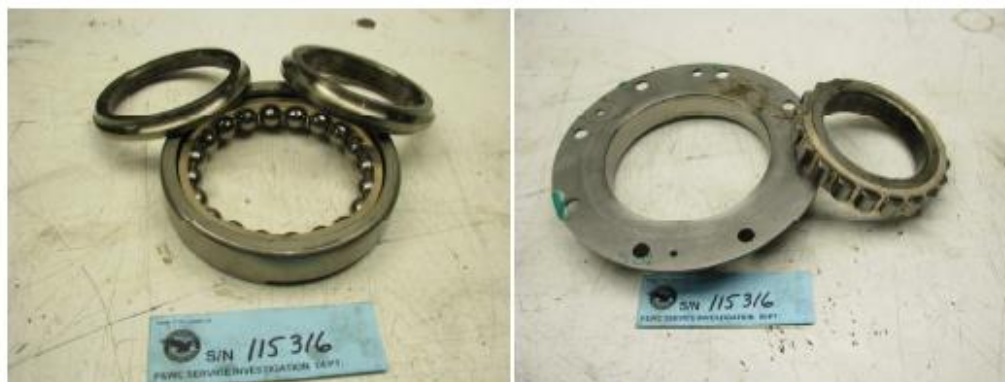
- 6.2 The propeller shaft, the bull and pinion gears and bearings (No. 15 to 19) of the 2nd stage reduction gear-train were in a satisfactory condition and could be manually rotated freely. Refer to photo no's 125 to 129.

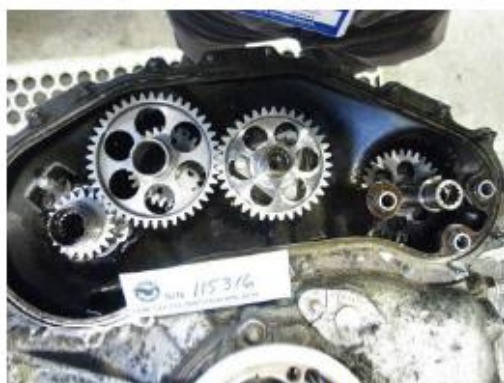
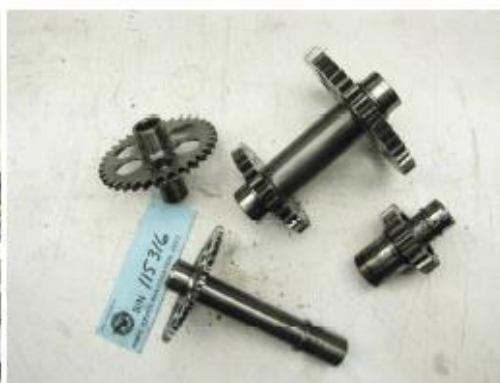
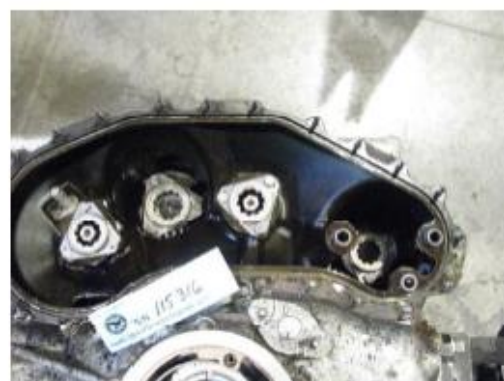
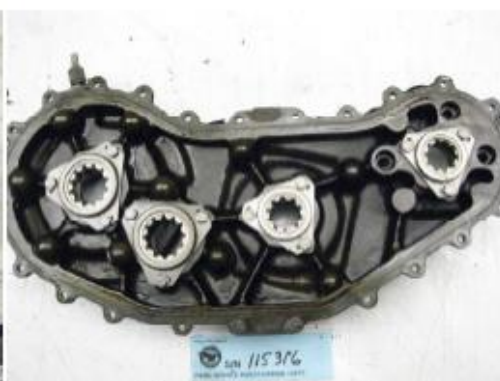
- 6.3 The accessory drive gears and bearings of the RGB module were in a satisfactory condition. Refer to photo no's 130 to 133.

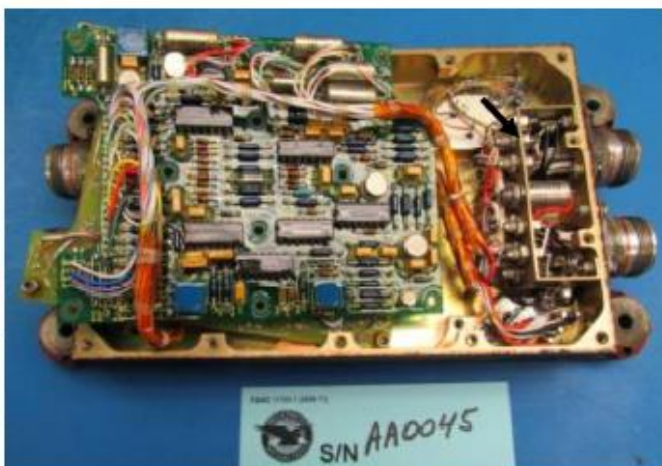
Photo no. 135

Visual inspection of the TSC in a dirty condition showed the lower RH mounting flange was bent. The Torque (TQ) trim plugs were missing. The electrical connectors (J6, J7, J10 & J11) were dirty but the connector contact pins were intact. The connectors were cleaned before the unit being bench-tested. The unit functional testing in accordance with calibration test-requirements showed all of the test points were successfully completed. The back cover was removed and the inspection of the electronic board displayed minor corrosion build-up on the filter support (arrow). Refer to photo no's 134 & 135.

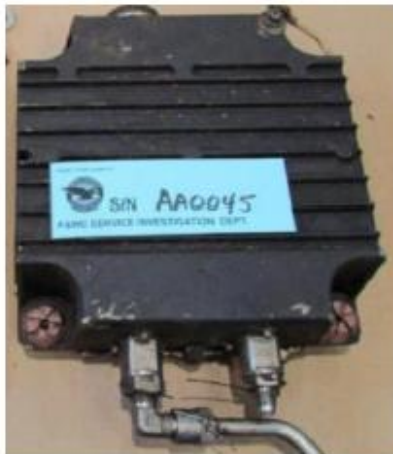
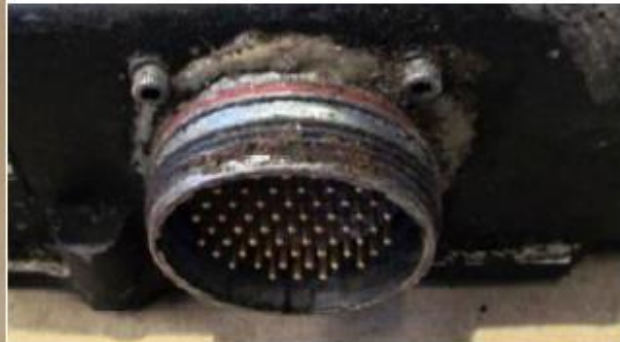
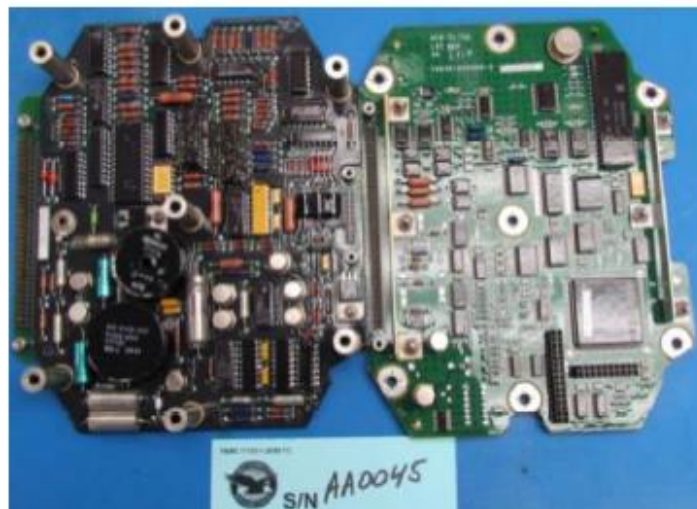
Visual inspection of the EEC in dirty condition showed the lock-wiring devices on the straight and elbow fittings of the transducer ports and the tube nut were found sectioned. The transducer ports were free and not obstructed from contaminants. The retention nut on the elbow fitting was found loose. The electrical connector was contaminated with sand and organic debris however no damage was observed to connector contact pins. The electrical connector was cleaned and the functional test that was performed in compliance with calibration testing requirements revealed all of the test points being successfully completed. The back plate was removed and the electronic boards were inspected revealing no damage or abnormal condition noted. Refer to photo no's 136 to 138.

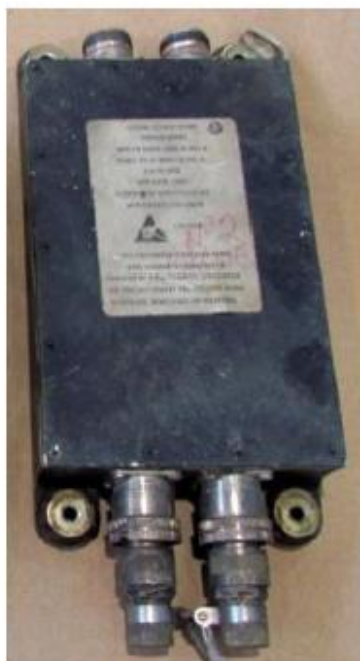
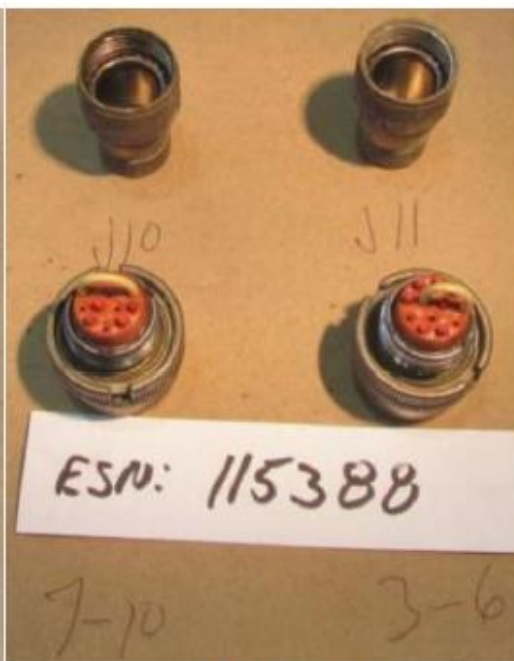
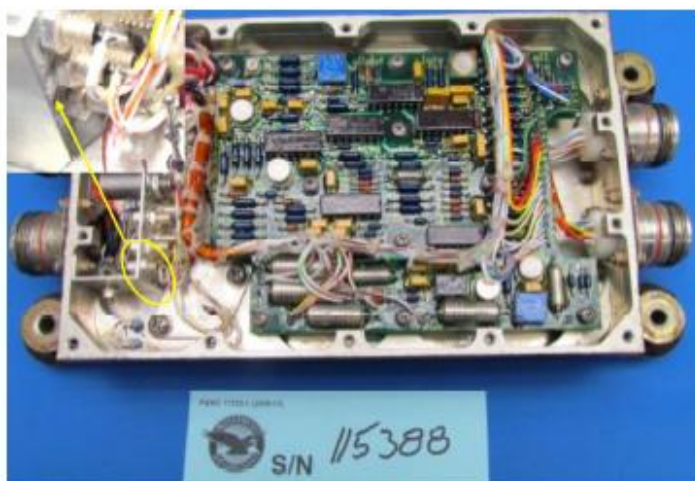
Visual examination of the TSC in dirty condition showed that its back-cover displayed minor denting and gouging damage. TQ trim plugs being rusted were attached to the unit with the presence of sealed locking-wires. The top electrical connectors (J6 & J7) were contaminated with dirt. TQ trim plugs (J10 and J11) were removed and inspected revealing the connectors to be clean and intact. Verification of the jumper position on the J10 trim plug (torque gain) was 7-10 identified as a Class 5 and the J11 trim plug (torque offset) was 3-6 as a Class 35 matching the scribed trim data on the engine reference data plate.

All connectors were cleaned and the functional test that was performed in accordance with calibration test-requirements revealing all of the test points met the calibration limits except for a minor calibration deviation of the torque indication at low propeller speed (Np) that would cause an approximately 0.005% low torque indication readout at idle speed only.

The back-cover was removed and inspection of the electronic board did display corrosion build-up (photo no. 141, yellow arrow) on the filter support bracket.

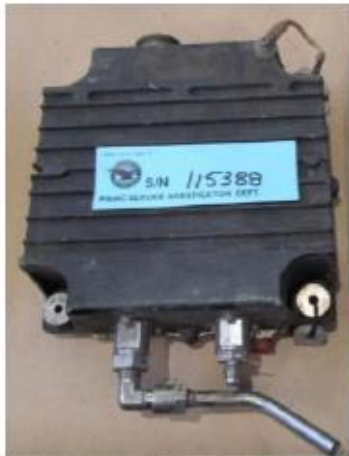
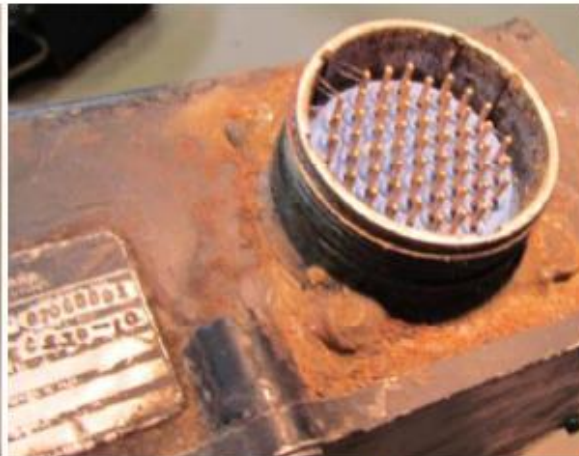
Visual inspection of the EEC in dirty condition showed the lock-wiring devices on the straight and elbow fittings of the transducer ports and the tube nut were found sectioned. The transducer ports were not obstructed and free of contaminants. The retention nut on the elbow fitting was found loose. The back cover showed multiple impact scratches. Electrical connector was dirty and the contact pins were intact.

The electrical connector was cleaned and the functional test as-is, in compliance with calibration testing-requirements, was aborted due to a faulty reversion light circuit being permanently "ON". The unit back plate was then removed. The inspection of the housing (internal) and electronic boards displayed a significant amount of water droplets and corrosion on the housing entire perimeter and in the area of the pressure transducers. A cracked solder joint was observed at the 28 volts Electro-Magnetic Interference (EMI) filter. A wire from the total pressure transducer (Pto) was found not fully seated in the electrical connector. The unit was dried, removing moisture, and the damaged solder joint and the unseated wire were repaired. Further testing of the EEC showed the unit satisfactory responding to all the commanded test points performed. The only anomaly detected was a slow air leak within the static air pressure transducer (Pso) generating a minor signal drift.

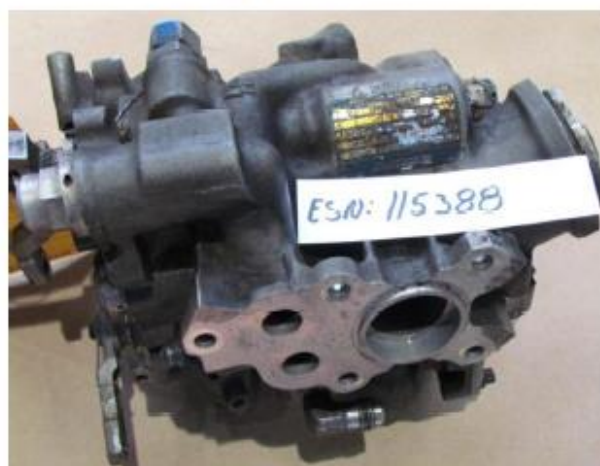
Photo no. 146

The HMFC was covered with dirt and the electrical connector was clean with no damage observed to contact pins (photo no. 146). All the lock-wires and seals were present and secured properly. Manual operation of the condition and power levers did not reveal any side play or abnormal resistance. All fuel and air ports were free of contamination. The result of the HMFC functionally test as-is in accordance with the supplier Component Maintenance Manual (CMM) calibration testing specifications showed some of the test points being out of calibration, however the test confirmed that the unit could supply the required fuel flow for take-off (TO).

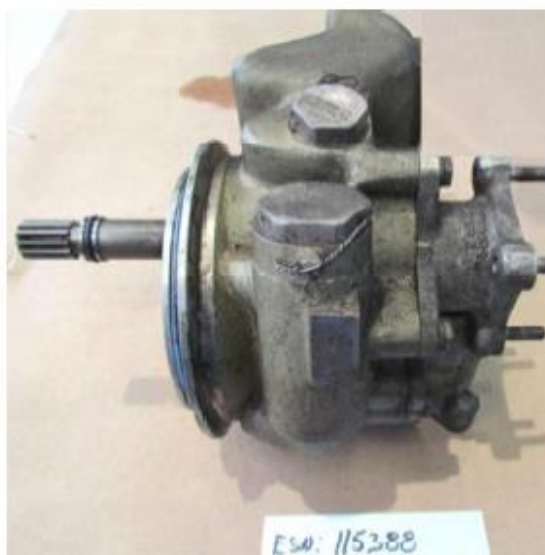
Photo no. 147

The pump was dirty and all lock-wires were present and secured properly (photo no. 147). No damage or abnormal condition was observed to the pump housing and drive shaft. An unapproved sealant tape was present at the pump mounting flange. The packing was chipped at a location (photo no. 148). The fuel filter was removed and found to be clean. The residual fuel collected from the fuel filter cavity showed no contaminants or water content. The fuel pump functionally test performed in accordance with the supplier CMM testing instructions revealed all the test points meeting requirements.

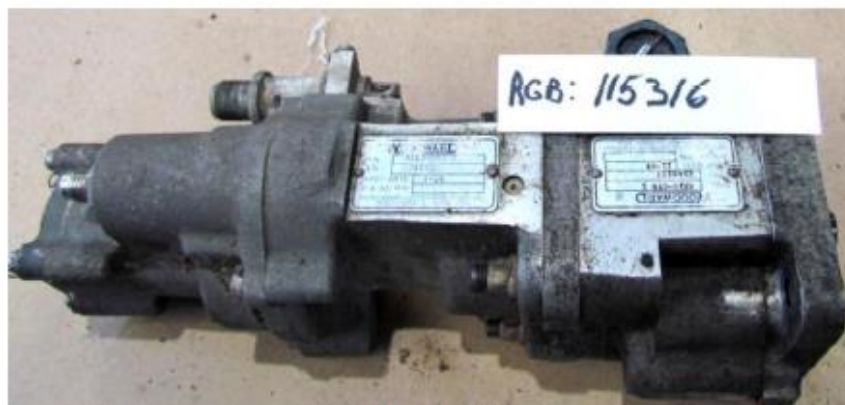
Photo no. 149

Both units as an assembly were covered with dirt and soot (photo no. 149). Air and oil ports were clean. The drive shaft could be manually rotated and showed no side play or abnormal resistance. The units were sent to the supplier for further investigation revealing that the inspection and testing of the Propeller Overspeed Governor and Hydraulic Pump did not reveal or confirm any malfunction issues.

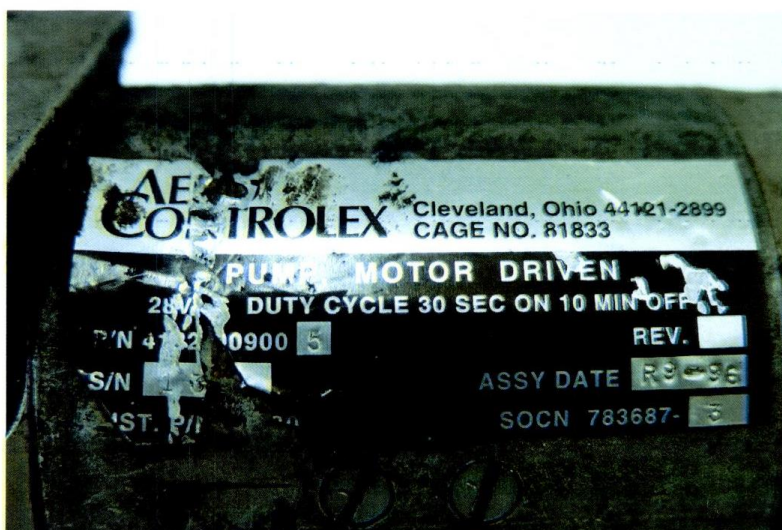
Figure 1
Pump Data Plate

This report documents the tear-down, inspection and testing of an auxiliary propeller feathering pump (ACX P/N 4122-009005, S/N 1386) which was installed on an Embraer 120 aircraft which was involved in an accident. Figure 1 below shows the data plate. The serial number is not fully legible in the as-received photo, but was reconstructed from the folded bits of the data plate that had come loose during shipping.

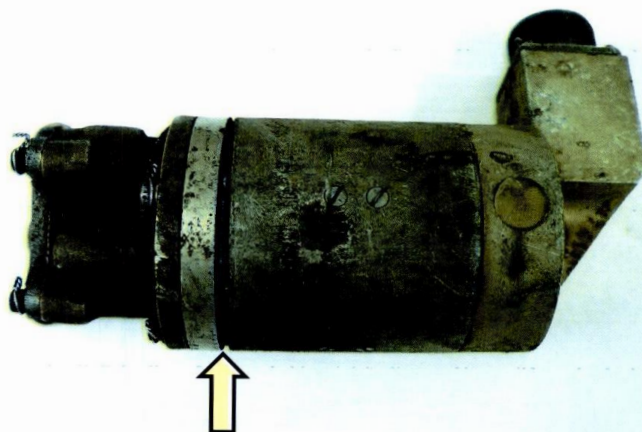
Figure 3
Pump and Motor Assembly, Front

- 2.1.1 Exterior examination of the unit showed that the electric motor housing had separated rendering the unit inoperable. See red arrows in Figures 2 through 4. The damage appears to have occurred when the aircraft impacted the ground. The pump subassembly itself appeared to be intact. The mounting flange, hydraulic transfer tubes and electrical connector were all in good condition. All fasteners and lock-wire were present and did not appear to have been disturbed. See Figures 2 through 5.

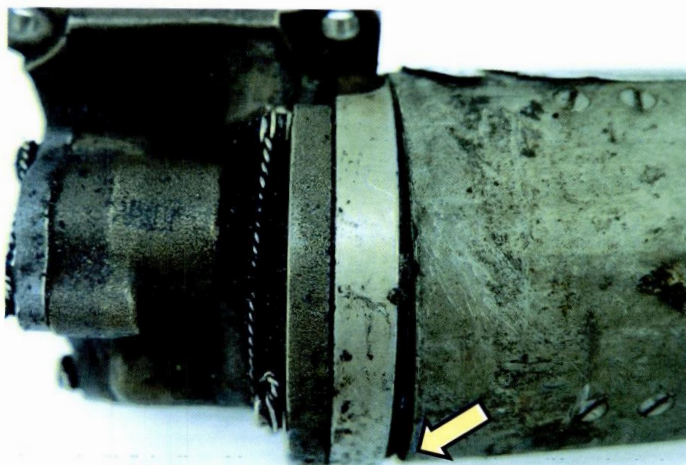
Figure 4
Close-up of Motor Housing Separation

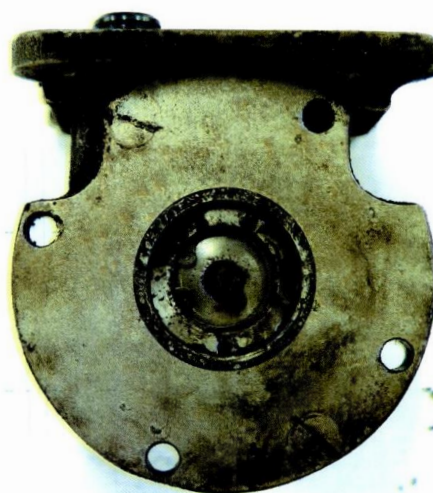
Figure 6
Pump Subassembly, Motor Mounting Surface

- 2.1.2 After a thorough visual examination and photographs were taken, the hydraulic pump sub-assembly was separated from the electric motor for further examination. This was done so the pump sub-assembly could be tested separately. The photos below show the interface where the pump sub-assembly mates to the electric motor. The mounting bolts and shaft were undamaged.

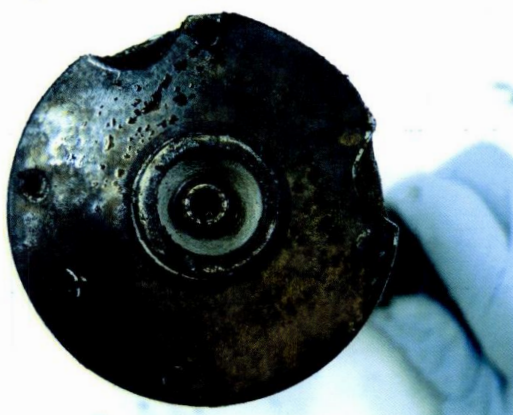
Figure 7
Electric Motor with Gasket and Coupler Installed

2.1.3 The pictures below are of the mounting surface of the electric motor and the shaft coupling that connects the motor to the pump sub-assembly. The mounting holes and coupler were undamaged. Figure 8 shows that the slotted countersunk screws that hold the motor housing together had not rotated despite the damage to the housing.

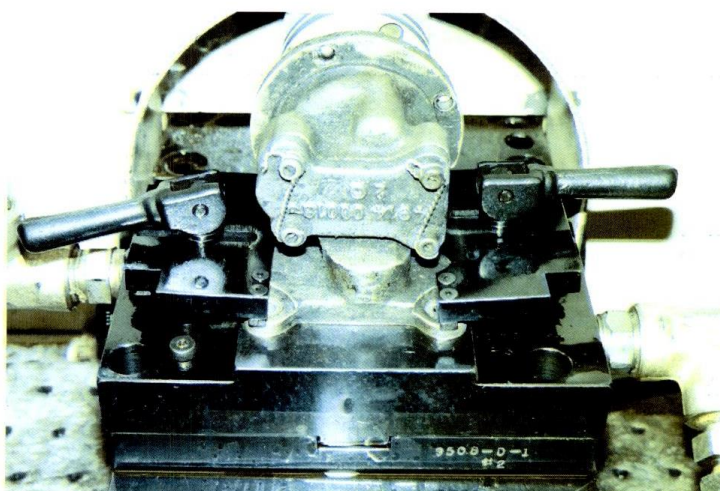
Figure 9
Pump Sub-assembly on Test Stand

2.3.1 After being separated from the electric motor, the hydraulic pump was tested in accordance with the CMM and production ATP. Figure 9 shows the pump installed on the ATP test stand.

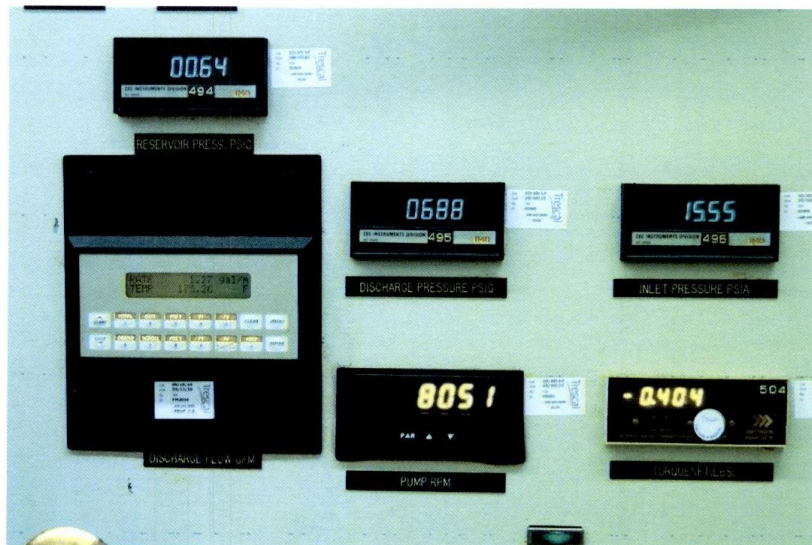
Figure 10
Test Stand Readouts

2.3.2 Figure 10 shows the digital readouts on the test stand for pressures, flow and RPM. Figure 11 shows the unit with the test data sheet.

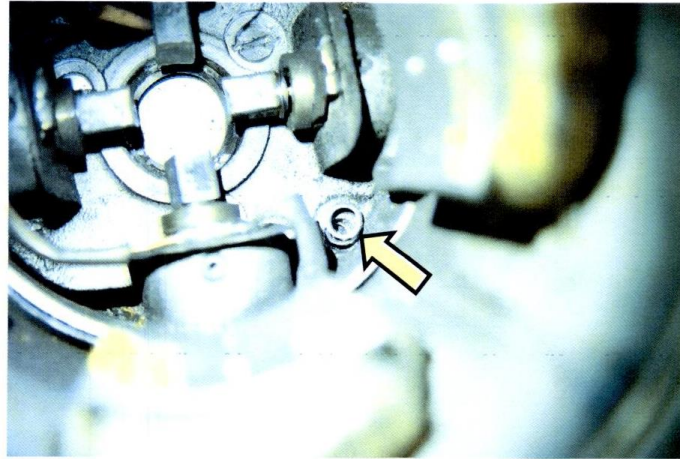
Figure 13
Motor Housing Clamping Helicoil Pulled Out

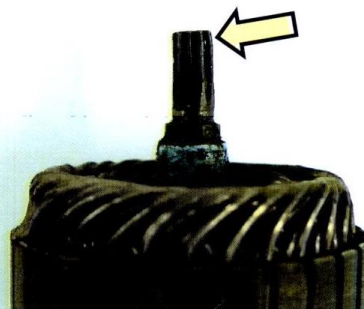
Figure 14
Motor Output Shaft Tip Bent

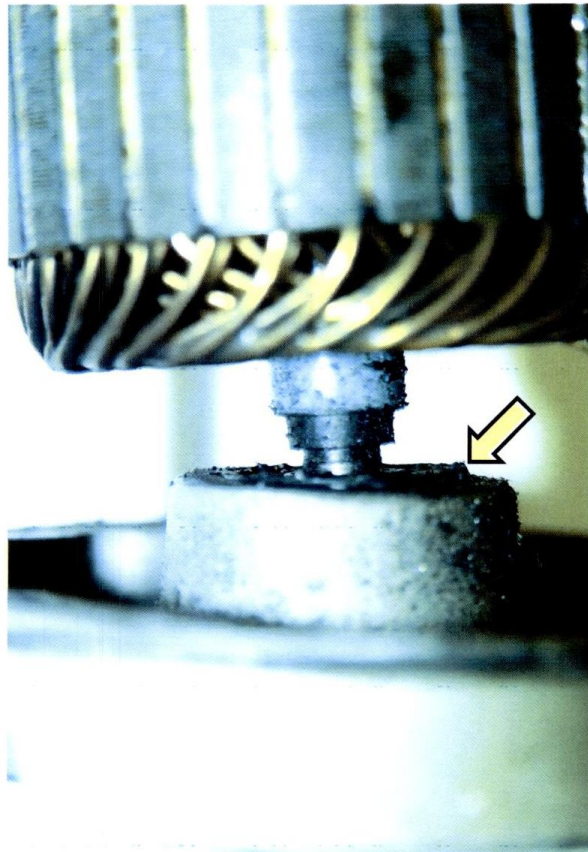
Figure 15
Motor Bearing Cocked at Output Shaft

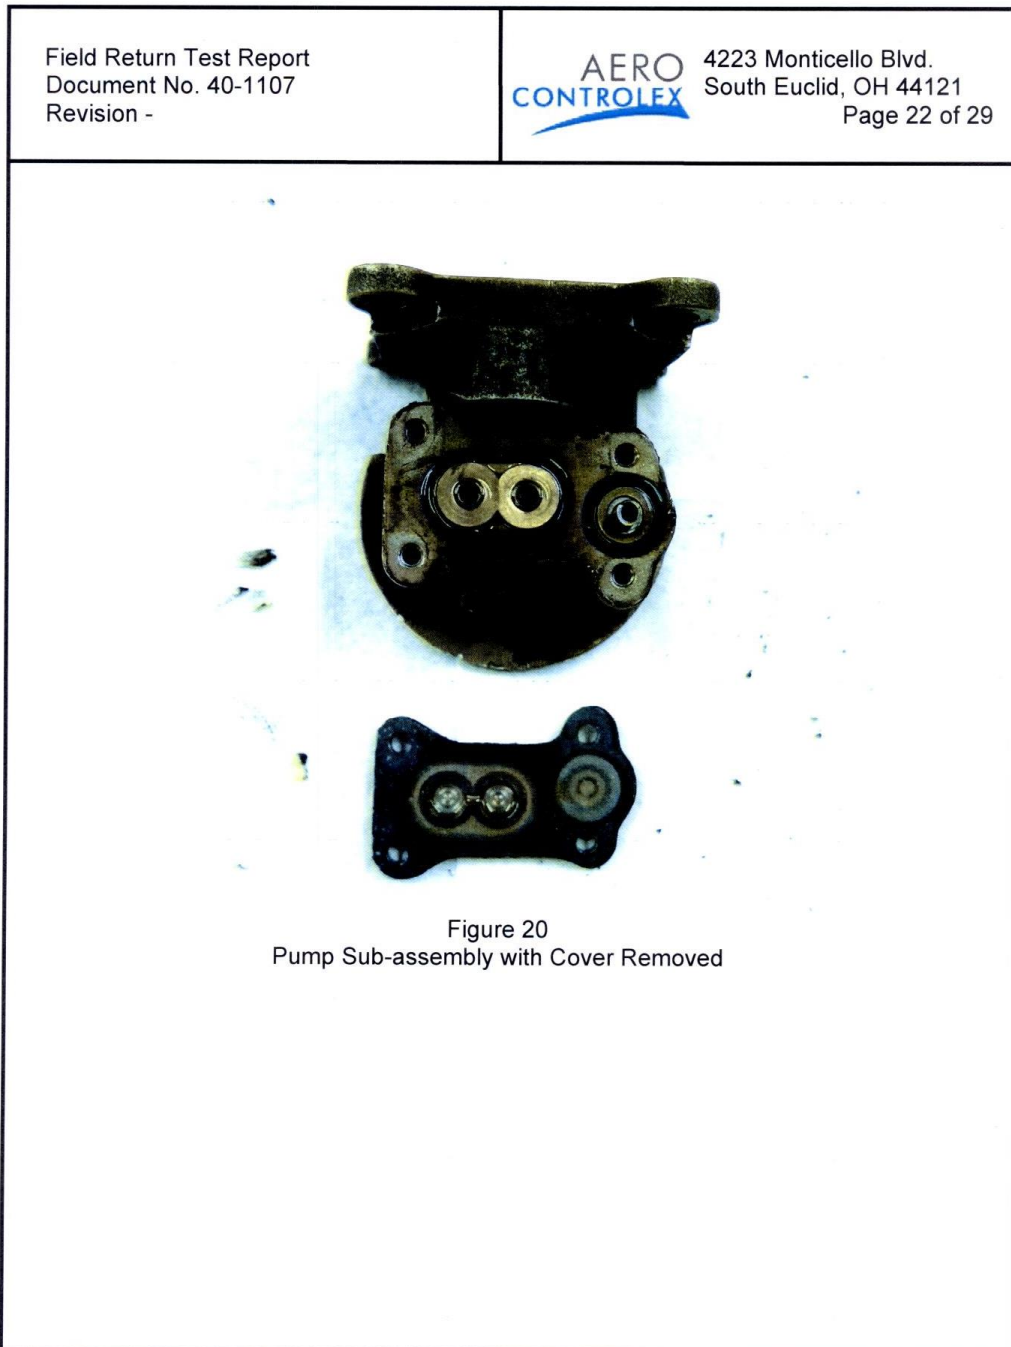
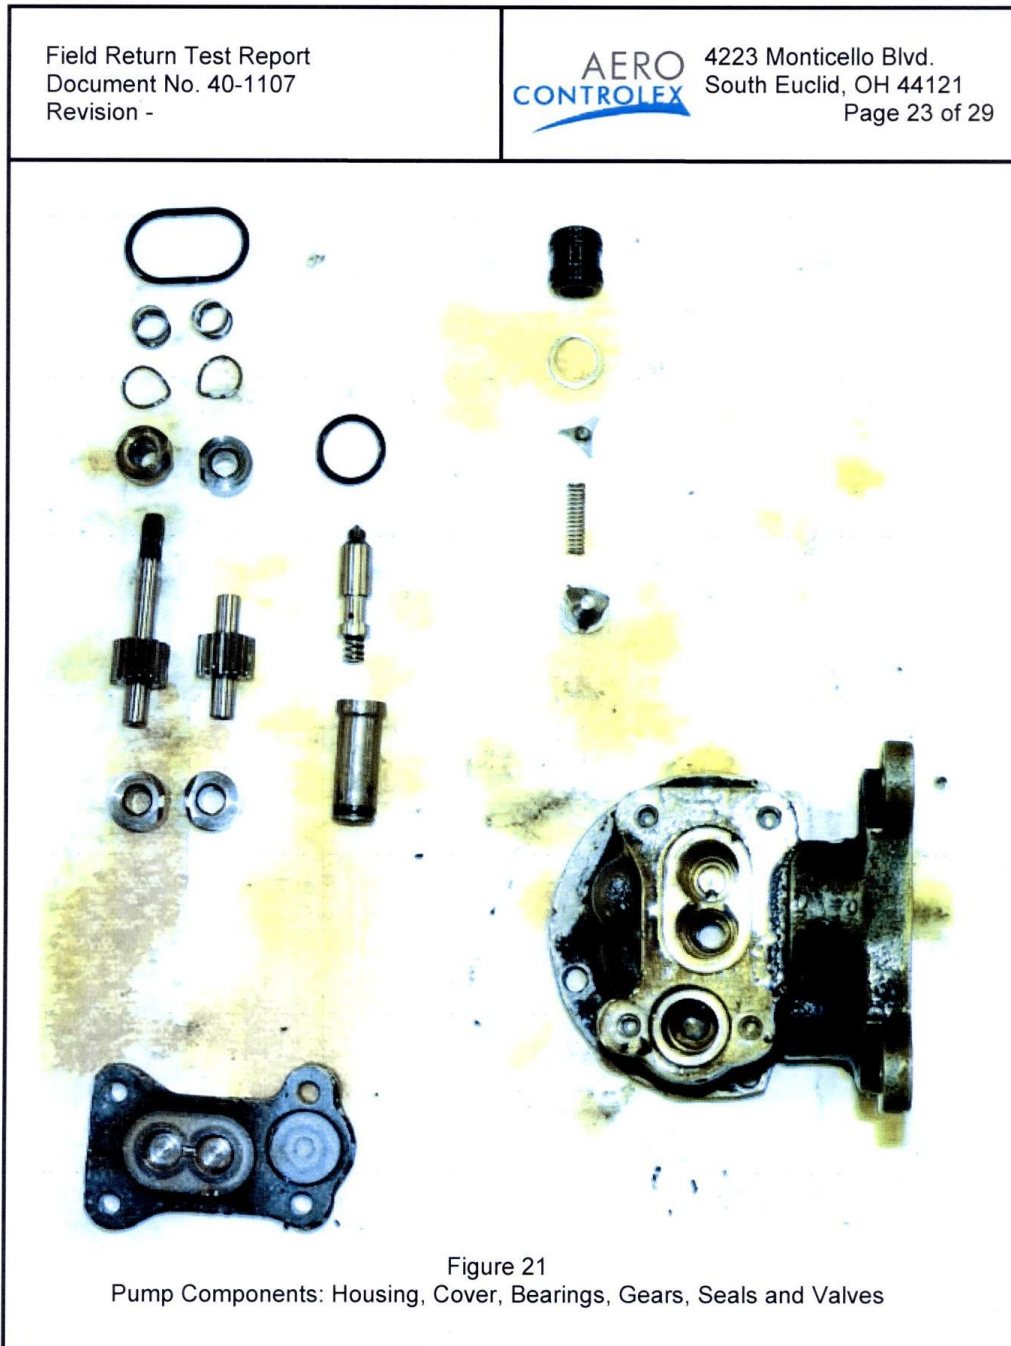
2.4.2.1 After being fully tested, the pump sub-assembly was torn down and inspected. Figures 20 through 22 show the pump sub-assembly, disassembly and components.

2.4.2.1 As is shown by the figures and testing, no anomalies were found with any parts of the pump sub-assembly. The pump sub-assembly was in working order at the time of the accident.

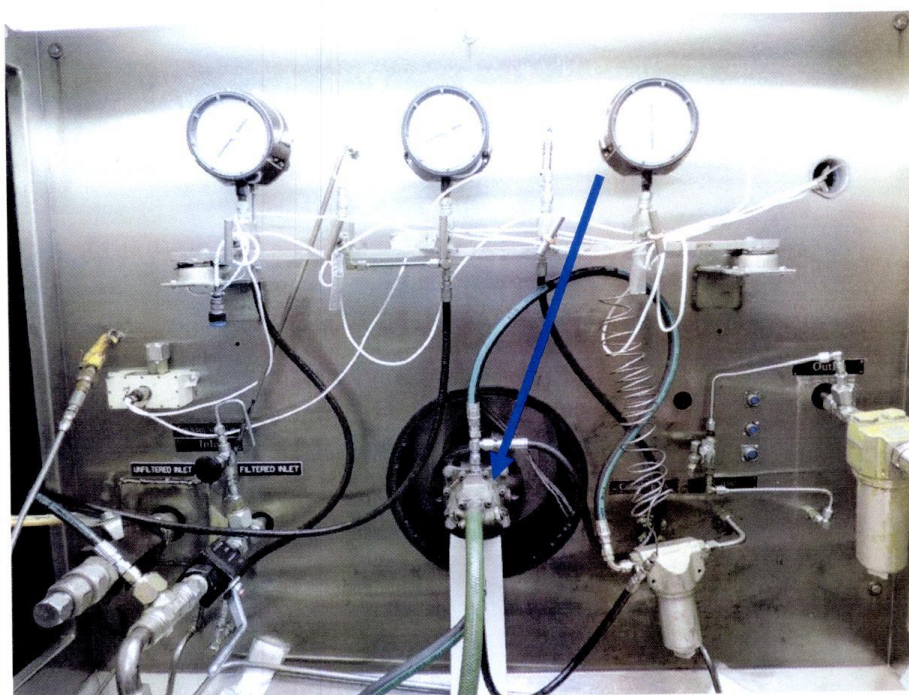
Photo 4 provides visual evidence of pump on the test stand. The pump was tested per the production TP – 8084.

The test stand setup for testing the pump is as used for production hardware. The test results are presented in Table I.
